1970-73 FORD MOTOR CO.

►CHANGES, CAUTIONS, CORRECTIONS

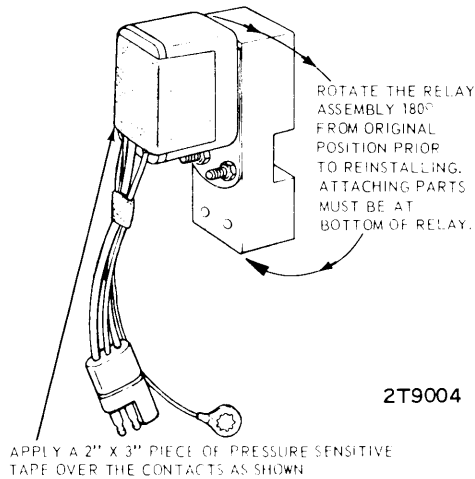
PROTECTION FROM WATER CONTAMINATION

- **1971 FoMoCo POWER WINDOWS INOPERATIVE-PREVENTING WATER CONTAMINATION OF RELAY:** Inoperative power windows may be caused by water entering power window relay. To correct condition, remove relay and apply a 2" x 3" piece of pressure sensitive tape over terminals (see illustration). Rotate relay 180° and reinstall with attaching parts at bottom of relay.

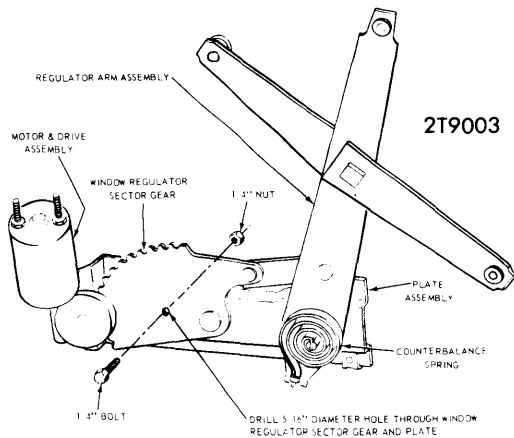
**MOTOR & DRIVE ASSEMBLY REMOVAL CAUTION**

CAUTION ALL MODELS (1970-73) – After removing regulator and motor from vehicle, mount assembly in vise and drill a 5/16" hole in the regulator sector gear and the regulator plate. Install a 1/4" bolt and nut in the hole. This **MUST BE** done to prevent gear from moving when the motor and drive assembly is removed from regulator. This also will prevent the chance of personal injury.
