BALL JOINT CHECKING

FACTORY RECOMMENDED METHOD

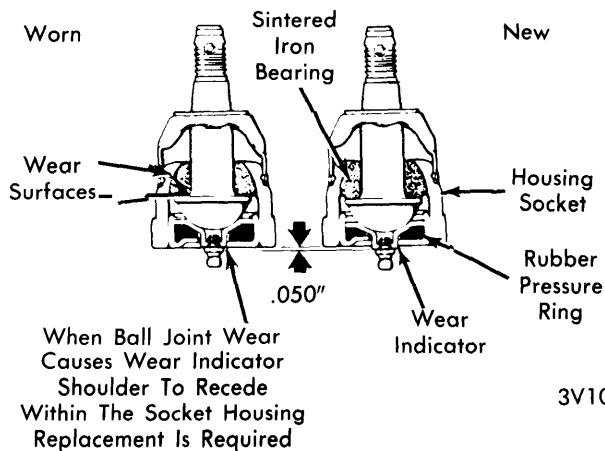
3V104

G.M. LOWER BALL JOINT WEAR INDICATOR

Lower Ball Joint — Wear is indicated visually. A new ball joint will show a 1/16" protrusion of round nipple into which grease fitting is installed. Replace ball joint if round nipple is flush or below surface of cover.

Lower Ball Joint (Exc. Eldorado) — Wear is inspected visually. A new ball joint will show a .050" protrusion of round nipple (at service plug). Replace ball joint if round nipple is flush or below surface of cover (see illustration).

Lower Ball Joint (Exc. Corvette & Nova) — Support vehicle on wheels or frame so lower ball joint is in a loaded condition. Ball joint features a visual wear indicator and is checked as follows: Wear is indicated by protrusion of 1/2" diameter nipple into which the grease fitting is threaded. On a new, unworn joint, round nipple projects .050" beyond surface

of ball joint cover. Normal wear will result in nipple retreating inward. If round nipple is flush with outside cover surface (see illustration), ball joint must be replaced.
