1973-74 GENERAL MOTORS

DESCRIPTION

TAILGATE WINDOW MOTOR REMOVAL & INSTALLATION

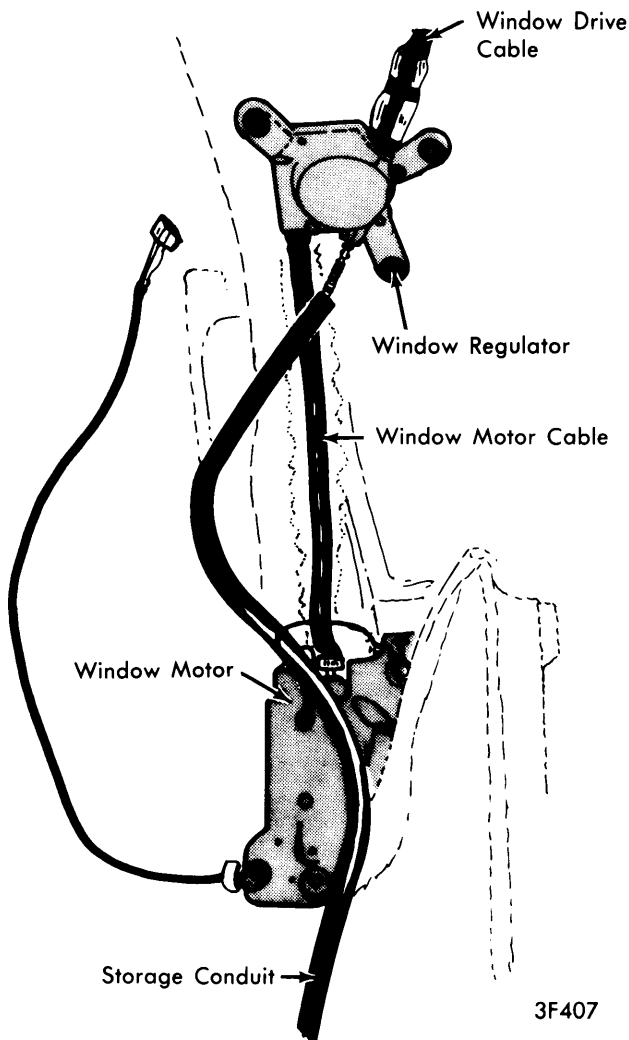
REAR WINDOW MOTOR & REGULATOR

General Motors uses only one type of power tailgate window on 1973-74 vehicles. This retractable type window is used exclusively on "B" body station wagons. Tailgate window retracts into space between roof and headliner. It can be operated by either the instrument panel switch, or external tailgate window control switch. An ignition relay prevents window operation from instrument panel switch without ignition switch being turned on. The window is controlled by a gearbox type regulator, 12 volt reversible motor with an internal circuit breaker, guide cams and rollers, drive cable, and lift spring. Motor and regulator assemblies are mounted to the rear of the spare tire well in right rear quarter. During window movement, the motor drives a cable, operating the window regulator gear. In turn, the regulator gear pulls a spiral cable connected to window guide cam. The spiral window cable is stored in conduit below regulator. Upward travel of window is assisted by a lift spring mounted in roof above headliner.

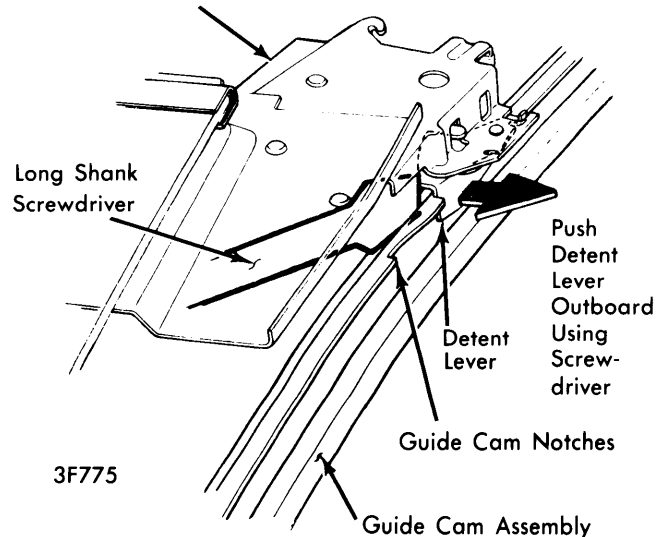
TRIPPING WINDOW LOCK MECHANISM

Right Upper Window Guide Assembly

3) Prior to lowering the window on manual tailgate styles, it is necessary to trip the lock with a long screwdriver to simulate tailgate being closed, this will allow glass to bypass guide cam notches (see illustration).
