## SAAB

99

### DESCRIPTION

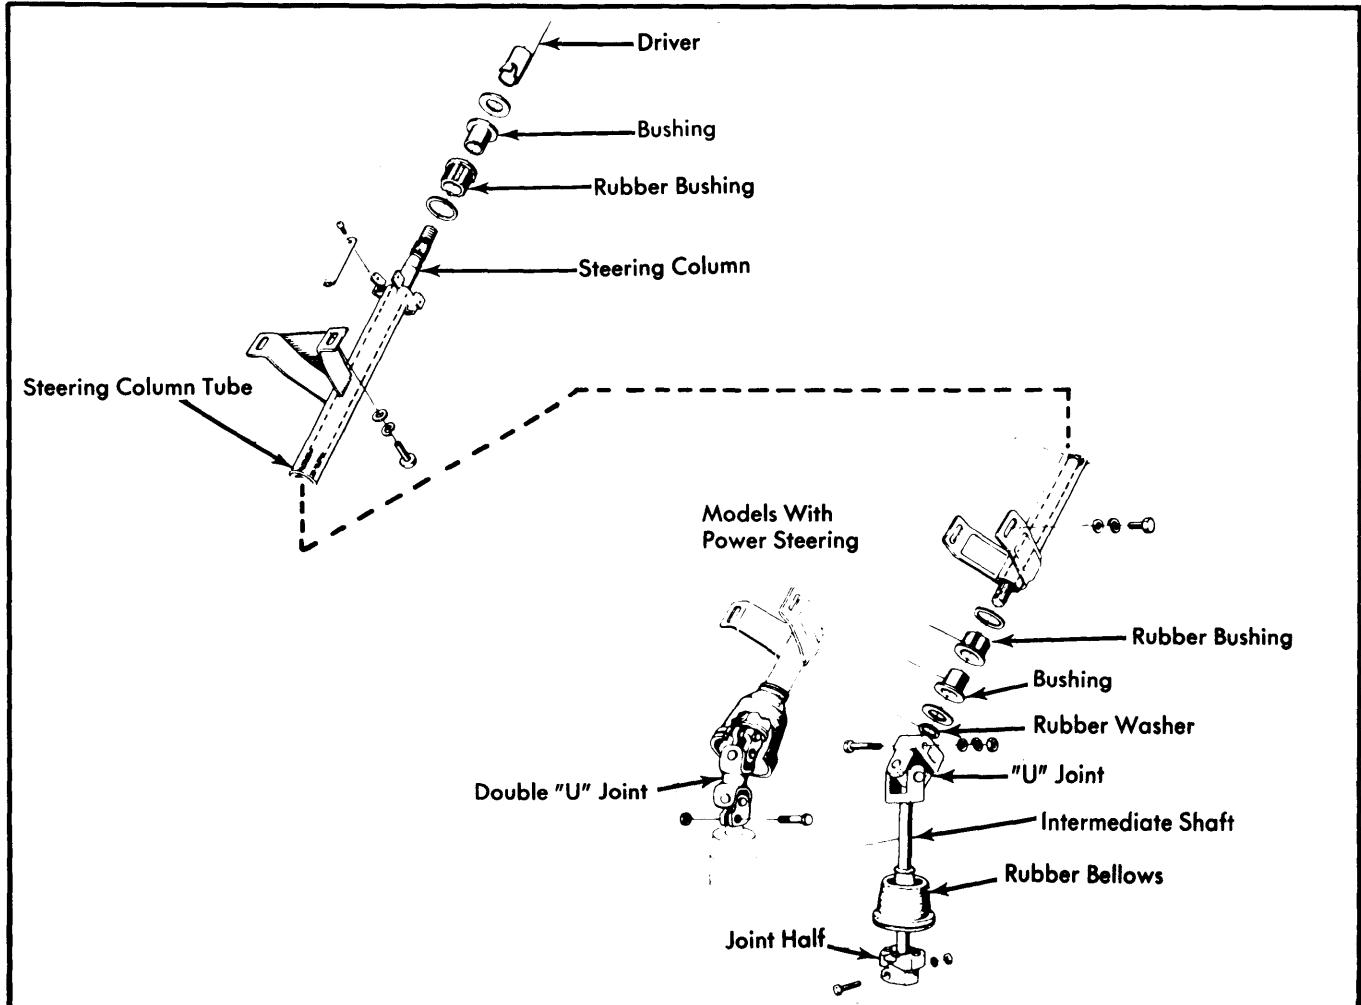
Fig. 1 Exploded View of Steering Column Assembly

**Disassembly** — Remove three retaining screws and remove plastic cover under steering wheel. Pull steering wheel shaft out of tube. Withdraw two rubber bushings with steering wheel shaft bushings and washers.

**Assembly** — To assemble, reverse disassembly procedure, after replacing required bushings.
