INTERNATIONAL HARVESTER

MS1210, 1310MHC, 1510 MHC

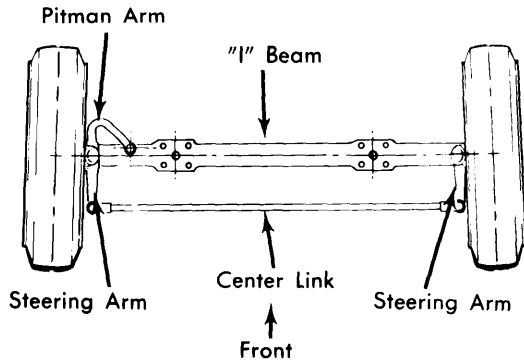
Fig. 1 Steering Linkage for MS and MHC Models

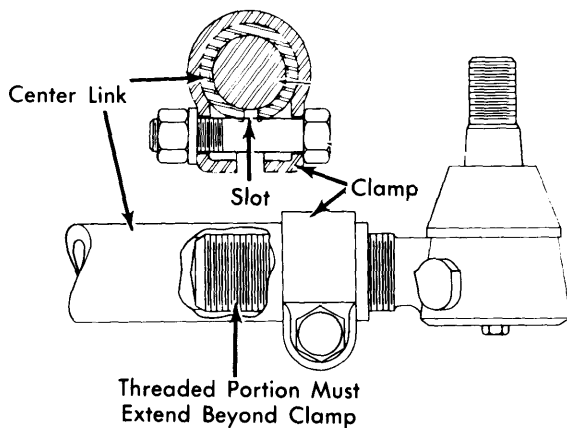
Fig. 2 Center Link Ends

Center Link Ends - When ball joint assemblies are replaced, they must be threaded into center link sufficiently so that when clamp is applied, clamping action will be directly over threads on ball joint assembly as shown in Fig. 2.

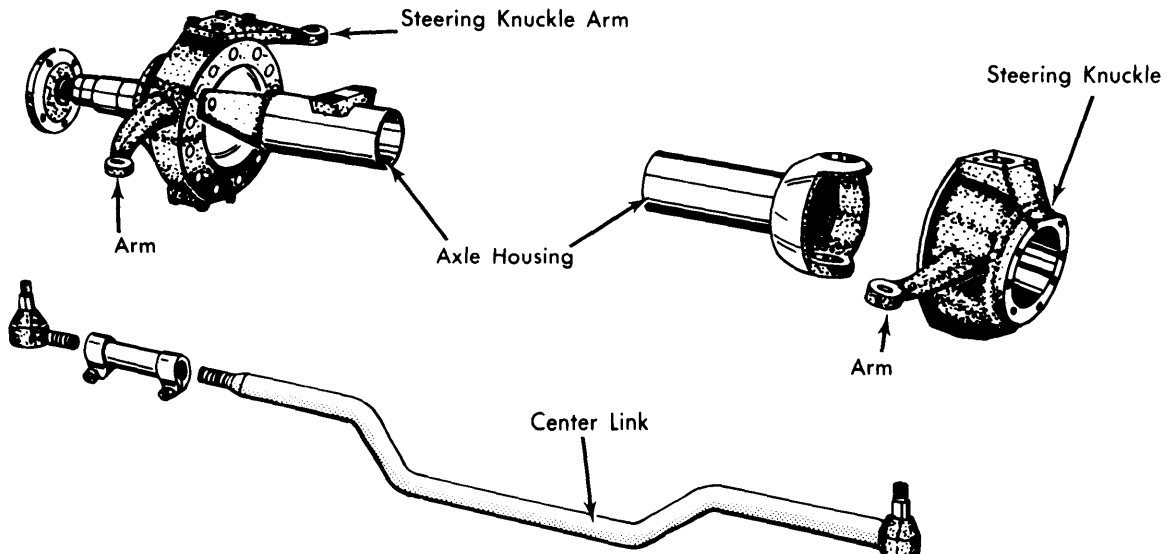
Fig. 4 Steering Linkage for 4-Wheel Drive Models

Ball Joint Replacement - Upper or lower ball joint replacement requires removal or disassembly of steering knuckle. See *Open Steering Knuckles in Drive Axle Section*.

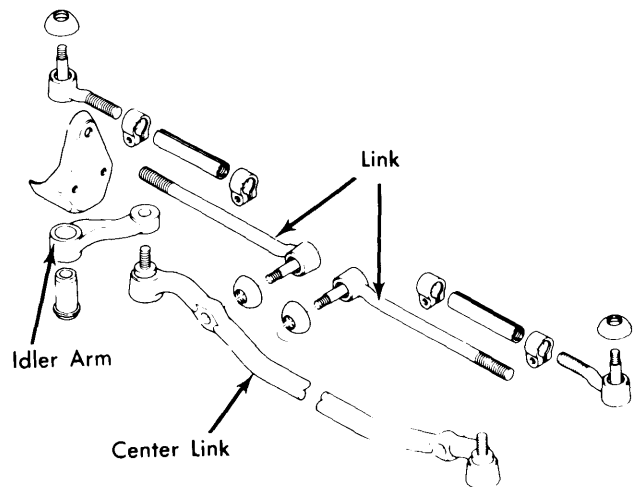
Fig. 3 Steering Linkage for 150 and 200

Ball Joint Lubrication - Remove plugs; lubricate under low pressure. Too much pressure will damage oil seals. In off-the-road operation where mud or water is encountered, lubricate more frequently.
